Innovative IGT Repair Solutions to Enhance Power Plant Profitability

By Kevin Davis, President of Frarendi, Inc.

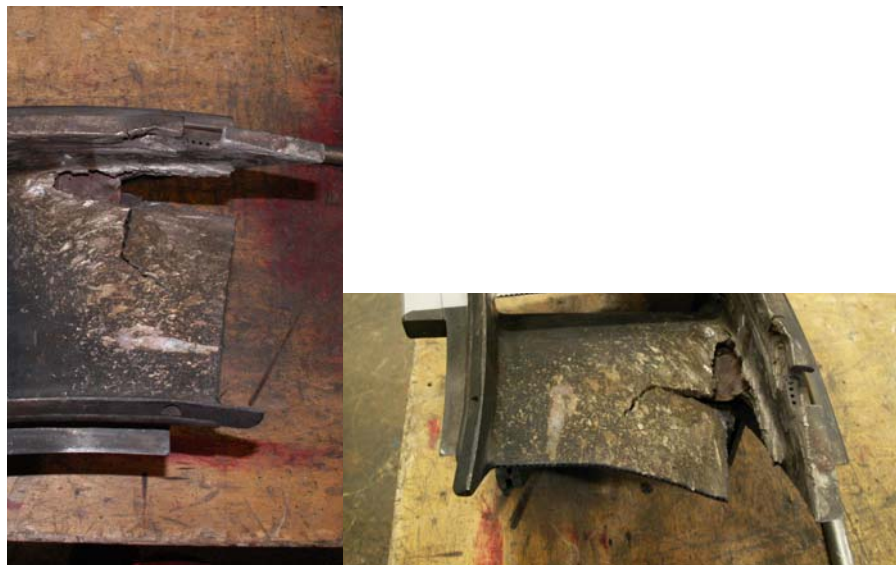
Figures 1 and 2. Foreign Object Damage to a First Stage Nozzle Segment - A perfect candidate for a trailing edge replacement coupon.

During the second repair cycle, extensive cracking and burning-away of the trailing edge base metal is common. This is called oxidation. At this point, the part requires a more holistic repair approach. Foreign object damage (FOD), such as failing combustion system components that are liberated downstream, can cause even more extensive distress or oxidation. A typical example of a first stage nozzle trailing edge with FOD is shown in figures 1 and 2. A decade ago, this part would have landed on a scrap heap. However, in today’s economy and with the exorbitant cost of replacement parts, this is a perfect candidate for a trailing edge coupon repair.

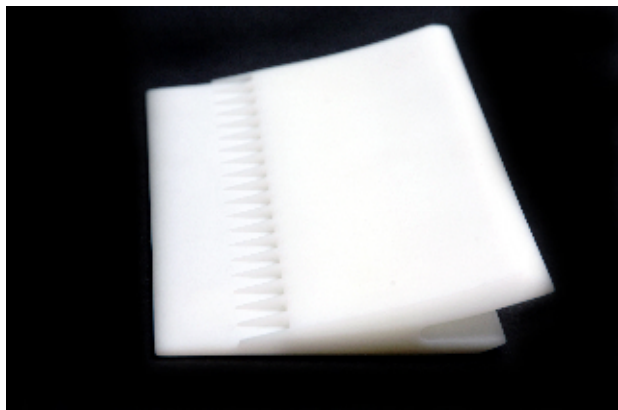
Figure 3. SLS of 7FA First Stage Nozzle Trailing Edge Replacement Coupon

First stage nozzle trailing edge replacement coupons are strategically designed and manufactured to be an exact dimensional and metallurgical match to OEM first stage nozzles. Using a new or refurbished OEM part, the surfaces of the nozzle rails, platforms and airfoils are laser or optically scanned and the data is imported into an industry standard CAD/CAM software package. Because nozzle airfoils are hollow to allow air to cool the part during operation, Computer Tomography (CT) scans, X-rays or cut-ups of the original part are used to determine the wall thickness and internal geometry features. Surface features, such as cooling air exit holes, are also measured. With this information, Stereolithography (SLA) or Selective Laser Sintering (SLS) is used to generate the prototype (Figure 3) to serve as a visual tool and as a way to initiate casting.

At this point, the coupon is ready to be machined. It is this stage of the manufacturing process that sets coupon suppliers apart and provides the service shop and power plant operator with the prospect of a high value, predictable repair method. As shown in Figure 3, the first stage nozzle is hollow and allows internally delivered cooling air through a series of holes or slots that cover the outside of the airfoil during operation. This air provides a boundary layer on the nozzle surface which prevents the nozzle material from melting under the extreme heat of the combustor-supplied gas, which can reach temperatures up to 3,000 degrees Fahrenheit.

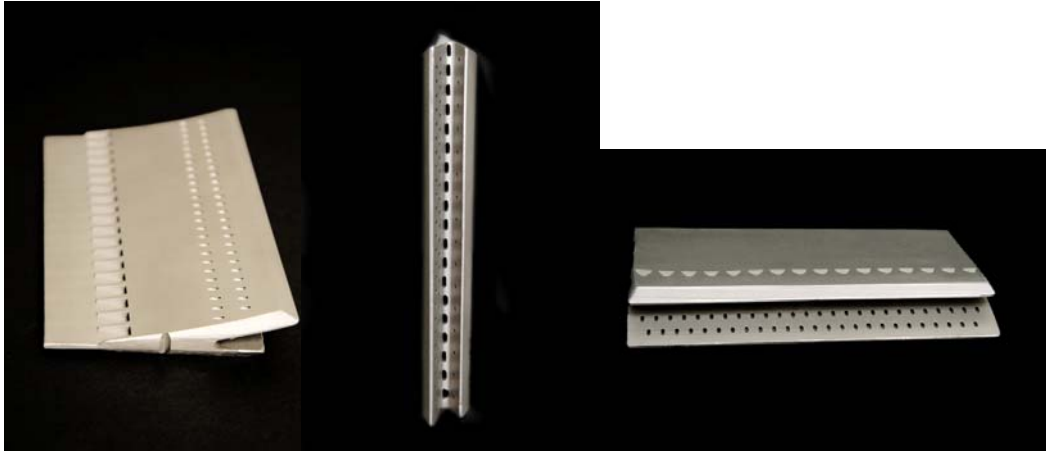
Figures 4 and 5. The 7FA Trailing Edge Replacement Coupon with cooling hole geometry made with the EDM process.

Additionally, some first stage nozzle designs also use thermal barrier coating (TBC), a yttria stabilized zirconia material, to further insulate the nozzle material from hot gas. Surface cooling is achieved through a system of intricate trailing edge slots and rows of shaped cooling holes on both the pressure and suction sides of the nozzle airfoil as shown in Figures 4 and 5.

The coupon becomes a valuable and robust process to service shops when the intricate cooling hole geometry is already machined into the coupon itself. The holes are made using an Electro-Discharge Machining (EDM) process that creates a highly accurate shaped hole geometry. EDM, in its simplest form, is machining using an electrical spark. A controlled electrical spark is used to erode away material that can conduct electricity. A series of controlled electrical discharges takes place between the two conductors separated from each other by a film of non-conducting liquid, called a dielectric or deionized water. When the electrode is plunged into the base metal, a hole is created. It is a highly specialized process which requires competencies in EDM tooling and equipment design, as well as electrode plunging methodologies.

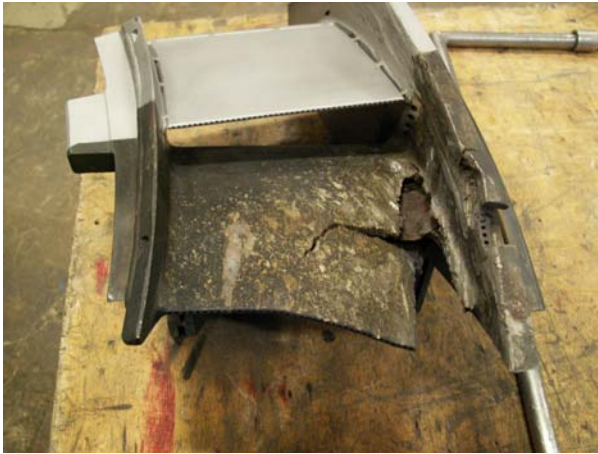
Figure 6. Trailing Edge Coupon shown ready to be welded into place. Note the small trailing edge cooling holes and the extent of damage to a nozzle segment that can be repaired.

With the coupon ready to be installed, the damaged nozzle segment is prepped for repair. Figure 6 shows a trailing edge replacement coupon being readied for welding on a GE Frame 6 nozzle.
